Total Land Subsidence in the Fort Grant Rd and Willcox Areas, Cochise and Graham Counties
Based on Radarsat-2 Satellite Interferometric Synthetic Aperture Radar (InSAR) Data

Time Period of Analysis: 1.0 Years 04/22/2017 To 05/11/2018

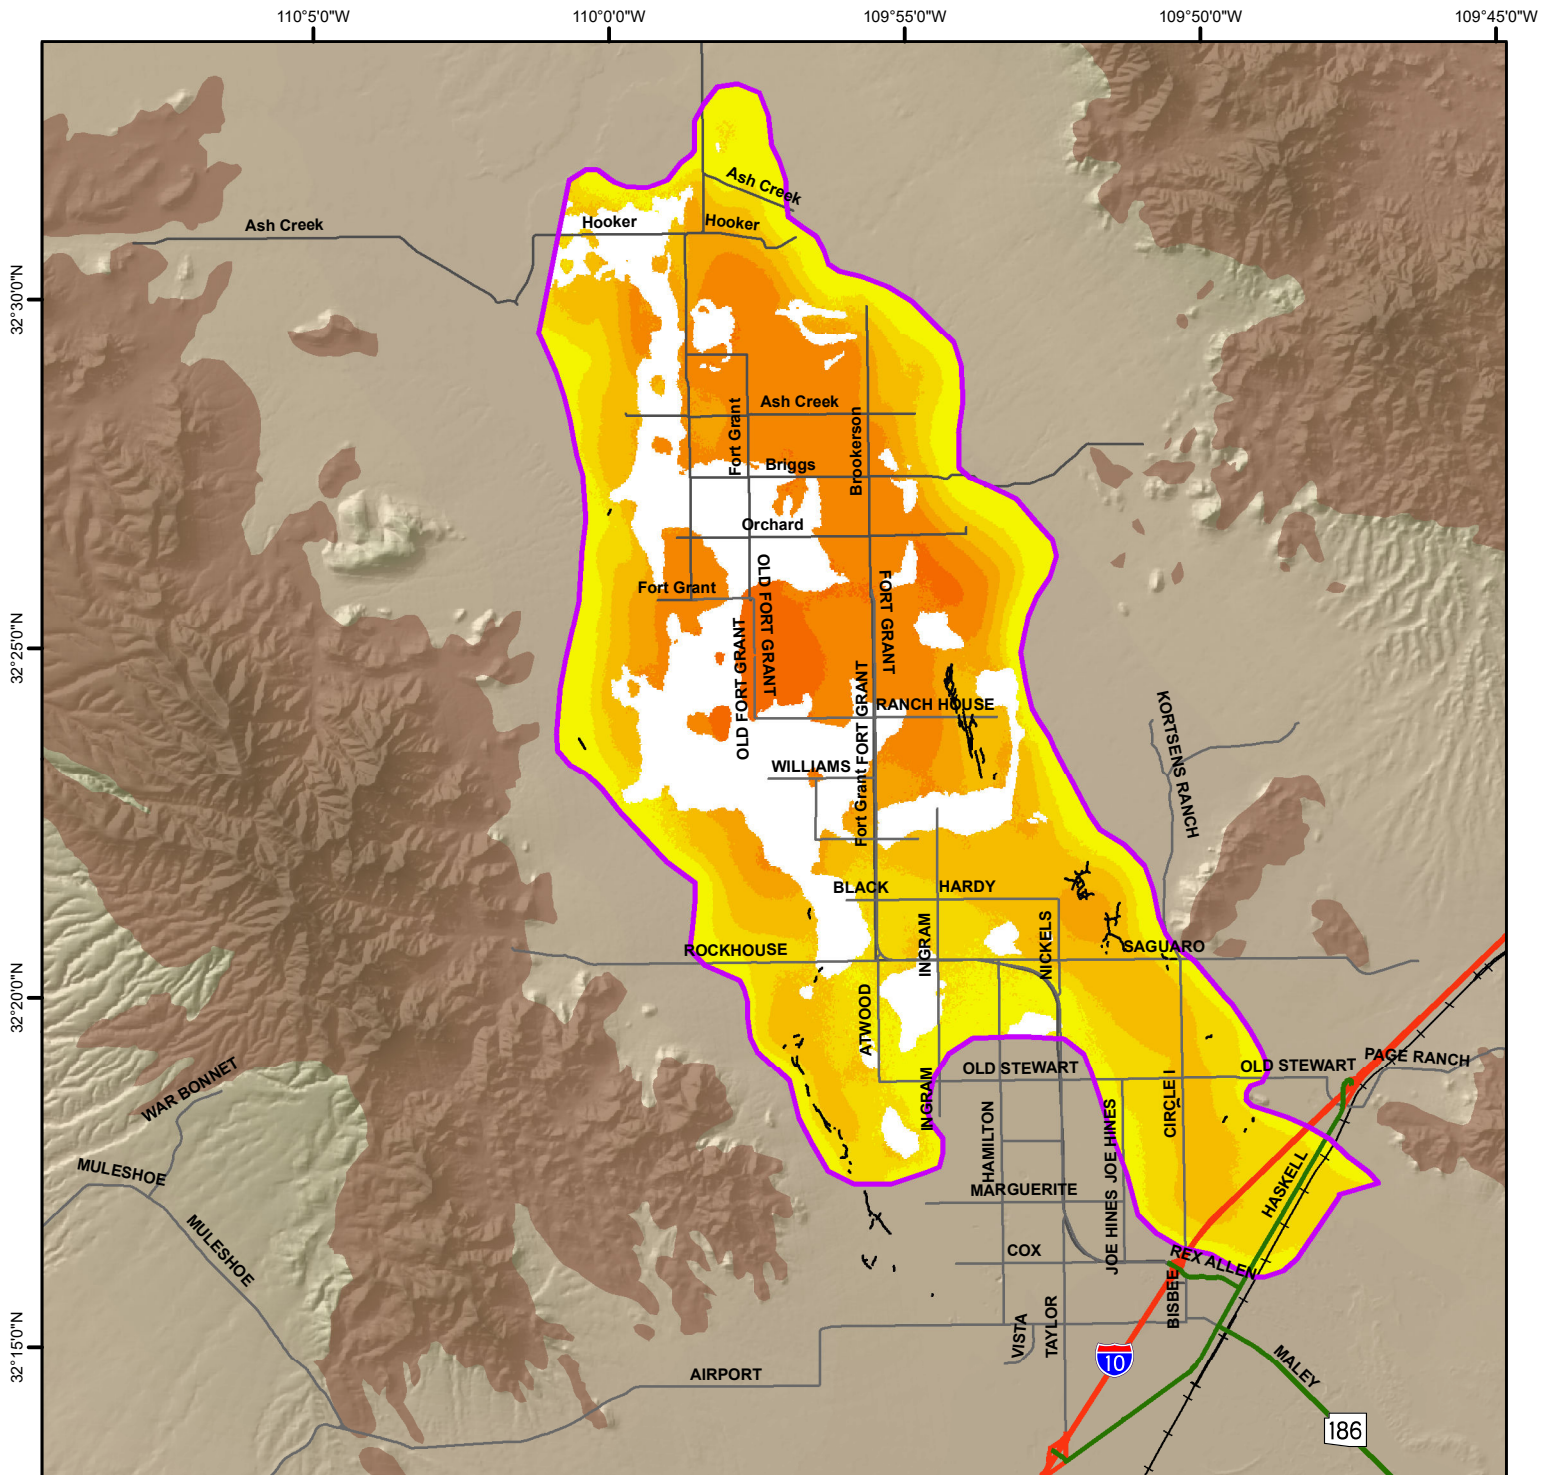
Decorrelation/No Data
Greater 40 cm (15.7 in)
25 - 40 cm (9.8 - 15.7 in)
15 - 25 cm (5.9 - 9.8 in)
10 - 15 cm (3.9 - 5.9 in)
6 - 10 cm (2.4 - 3.9 in)
4 - 6 cm (1.6 - 2.4 in)
2 - 4 cm (0.8 - 1.6 in)
1 - 2 cm (0.4 - 0.8 in)
0 - 1 cm (0 - 0.4 in)

Decorrelation (white areas) are areas where the phase of the received satellite signal changed between satellite passes, causing the data to be unusable. This occurs in areas where the land surface has been disturbed (i.e. bodies of water, snow, agriculture areas, areas of development, etc).

Earth fissures were mapped by the Arizona Geological Survey.
For information on earth fissures visit: www.azgs.gov/EFC
